# การวิเคราะห์ความเสียหายจากการกัดกร่อนแบบการกัดเซาะของระบบท่อลมขนส่งฝุ่นยาสูบ Failure Analysis of Erosion Corrosion on Air Pipe System for Transporting Tobacco Dust

Pramual Wangkasem<sup>1</sup> and Tanong Nititeerachote<sup>2</sup>

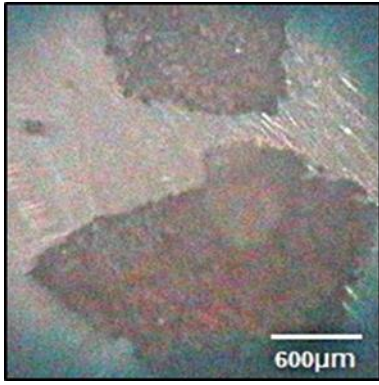
(a) larger than 850 micron

Figure 1, it can be seen that the tobacco dust particles are angular at a pressure of 80-100 bar; it forms a corrosion-erosion pattern.

Fig. 1 Structure of tobacco dust

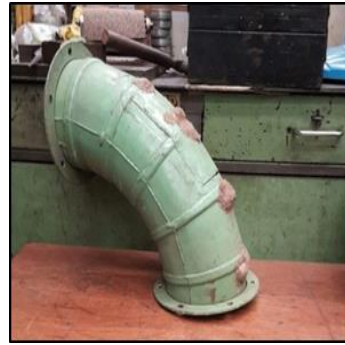
Fig. 2 Piping of tobacco dust during curves and arched parts of damaged pipes

(4) Figure 2 (a) is the curve of the pipe. Figure 2 (b) (c) and (d) are parts of the pipe cut off the tobacco dust. It can be seen that the pipe is shaped like a steel plate, intermittently connected, maybe another factor that causes the pipe to damage frequently.

Suggestion from the problems encountered, there are many possible solutions, such as selecting a pipe with a low friction coefficient (slip surface) in a circulating air duct system, design the pipe joints to bend into a single piece of material without excessive joints, and design the removal of tobacco dust from the beginning of the separation without going through the circulating air duct system.

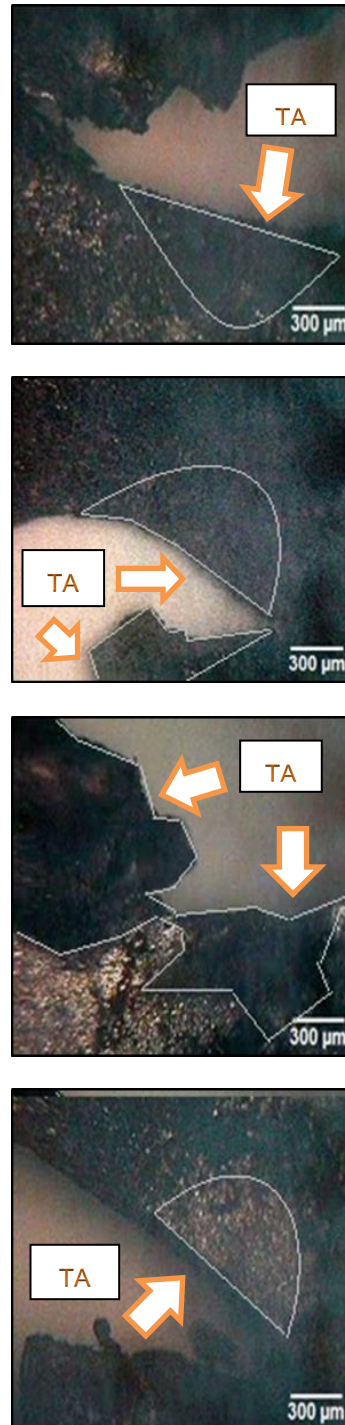
Fig. 3 Parts of the damaged pipe from a light microscope

Figure 3 is a picture obtained from the optical microscope shows that the welded range is torn and the skin near the area (Thin Area: TA) was defects which is the form of corrosion damage. The cause is due to many factors, including the wind force in the system.
